Home Inspection Report

0 St
Springfield, Connecticut 06082

Inspected by:
Ernest Harris
Harris Property Inspections

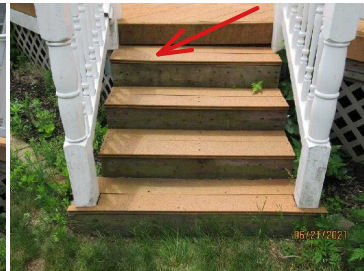
3. ☐ ☐ ☐ ☐ ☒ Steps/Stoops: Handrails not secure, Steps not secured, A qualified contractor is recommended to evaluate and estimate repairs

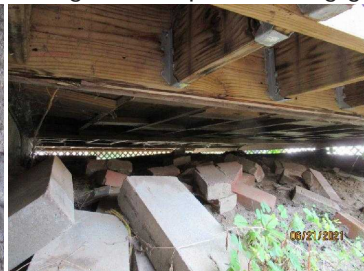
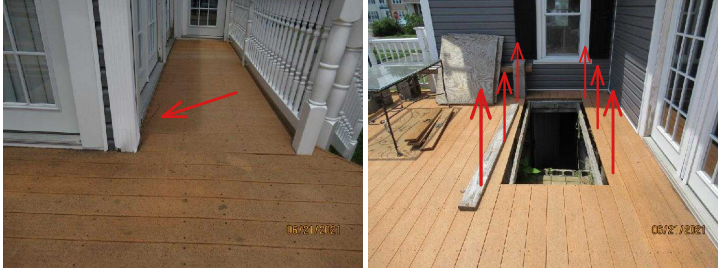
6. ☐ ☐ ☐ ☐ ☒ Deck: Structurally unsound, Not built to code or standards, Negative slope , Missing guard rails

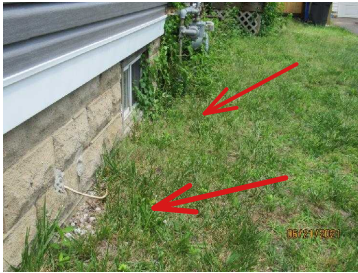
8. ☐ ☐ ☐ ☒ Grading: Grading has negative slope and water is pooling against the foundation.

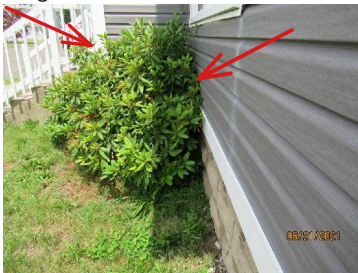
10. ☐ ☐ ☐ ☒ Vegetation: Bushes too close to structure should be trimmed back 1 foot

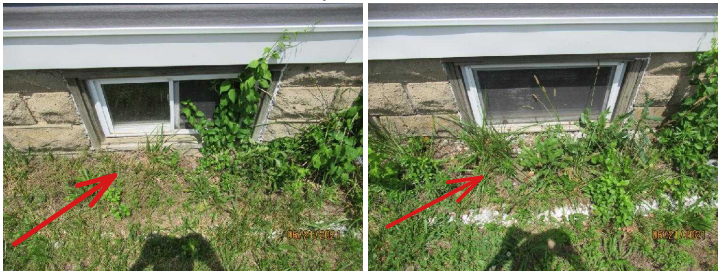
11. ☐ ☐ ☐ ☐ ☒ Window Wells: Missing, At grade or below grade level, A qualified contractor is recommended to evaluate and estimate repairs

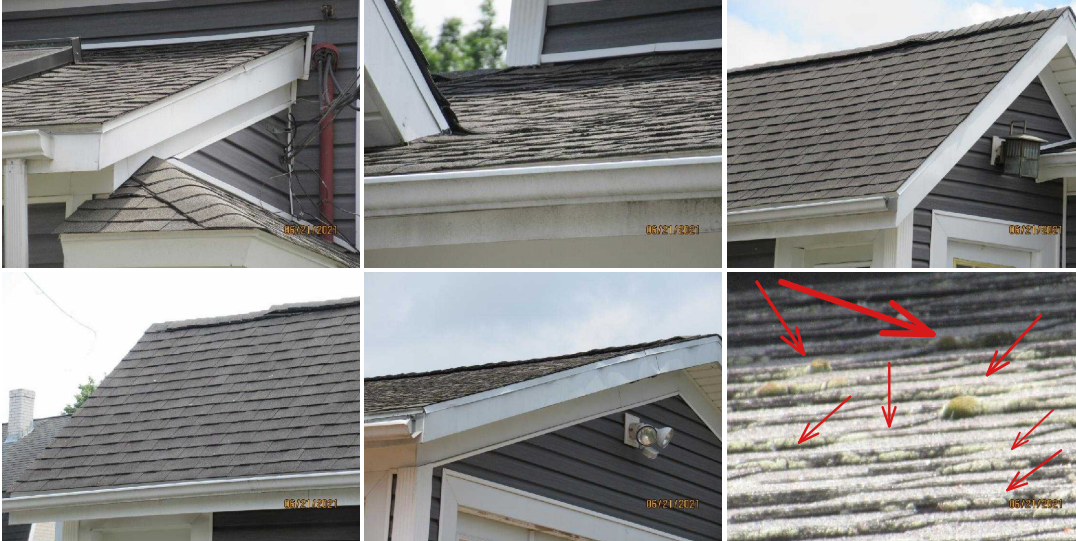
2. ☐☐☐☐☒ Material: Asphalt shingle - Moss growth on roof shingle surface, A qualified roofing contractor is recommended to evaluate and estimate repairs
3. Type: Gable
4. Approximate Age: 10-15 years
5. ☒☐☐☐☐ Flashing:
6. ☒☐☐☐☐ Valleys:
7. ☒☐☐☐☐ Skylights:

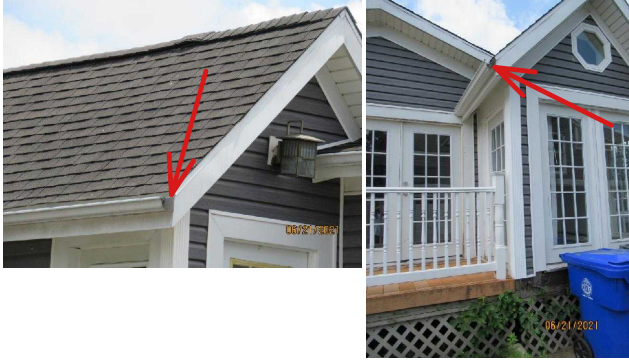
11. ☐☐☐☒☐ Downspouts: Missing

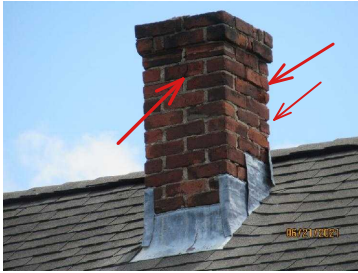
13. ☐☐☐☒☐ Chimney: Bricks have broken or popped surfaces- repairs required, Chimney requires tuck point repairs, A qualified contractor is recommended to evaluate and estimate repairs

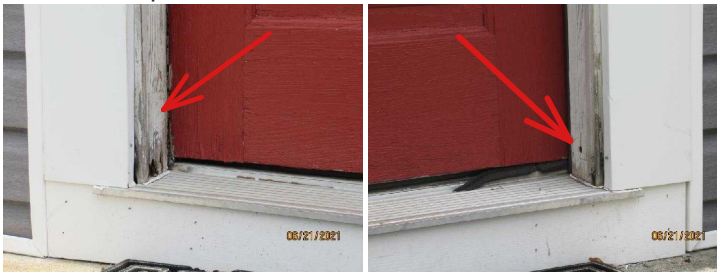
5. ☐ ☒ ☐ ☐ ☐ Door Bell:
6. ☐ ☐ ☐ ☐ ☒ Entry Doors: Wood rot, Paint peeling, A qualified contractor is recommended to evaluate and estimate repairs

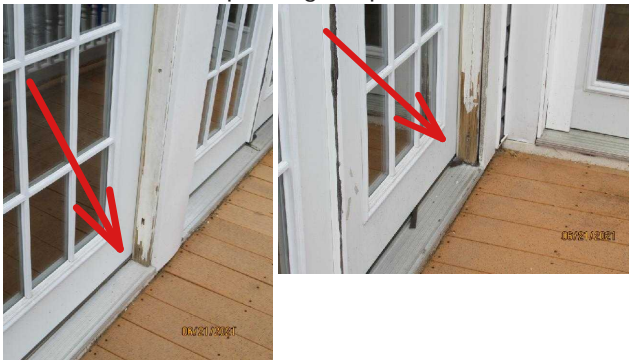
7. ☐ ☐ ☐ ☐ ☒ Patio Door: Paint peeling, A qualified contractor is recommended to evaluate and estimate repairs

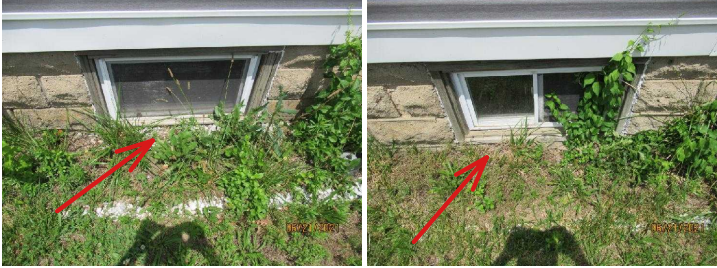
11. ☐☐☐☐☒ Basement Windows: Below grade without window well

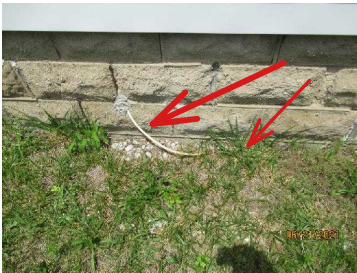
13. ☐☐☐☐☒ Exterior Electric Outlets: Exposed wiring present, Suggest to have a license specialist check and evaluate this condition

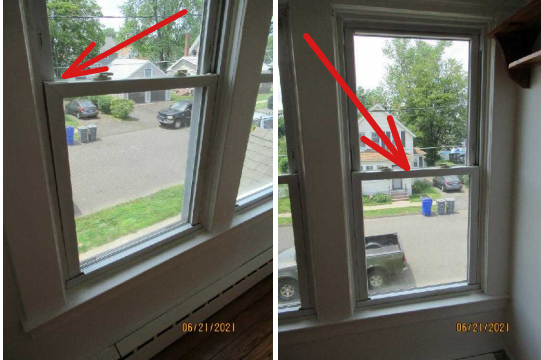
14. ☐☐☐☐☒ Windows: Repair faulty operating hardware, Missing window screens, A qualified glazier is recommended to evaluate and estimate repairs

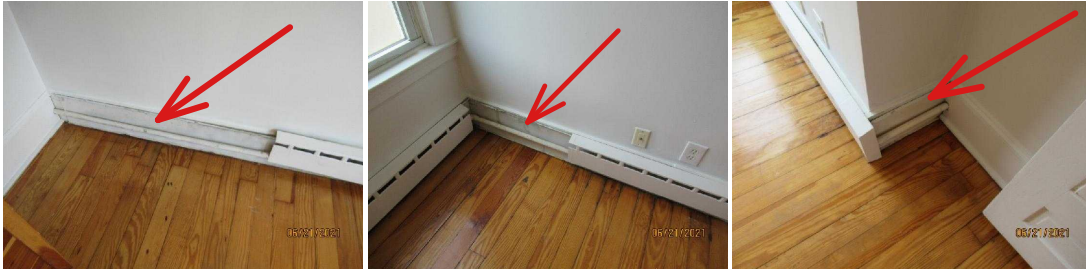
16. ☐☐☐☐☒ HVAC Source: Heating system inoperable, Register cover missing

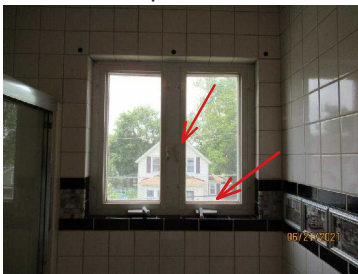
1. ☒ ☒ ☐ ☐ ☐ Closet:
2. ☒ ☐ ☐ ☐ ☐ Ceiling:
3. ☒ ☐ ☐ ☐ ☐ Walls:
4. ☒ ☐ ☐ ☐ ☐ Floor:
5. ☒ ☐ ☐ ☐ ☐ Doors:
6. ☐ ☐ ☐ ☐ ☒ Windows: Repair faulty operating hardware, A qualified glazier is recommended to evaluate and estimate repairs

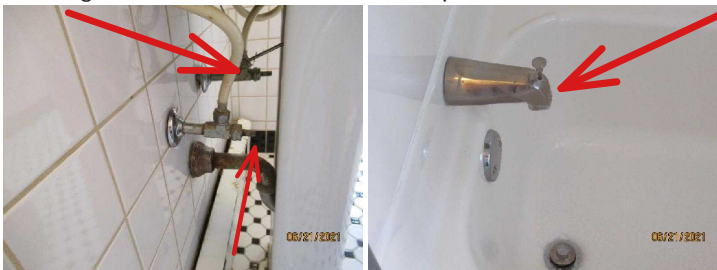
8. ☒ ☐ ☐ ☐ ☐ Counter/Cabinet:
9. ☒ ☐ ☐ ☐ ☐ Sink/Basin:
10. ☐ ☐ ☐ ☐ ☒ Faucets/Traps: Shutoff valve defective, Shower diverter not functioning properly, all water is not flowing to showerhead, A licensed plumber is recommended to evaluate and estimate repairs

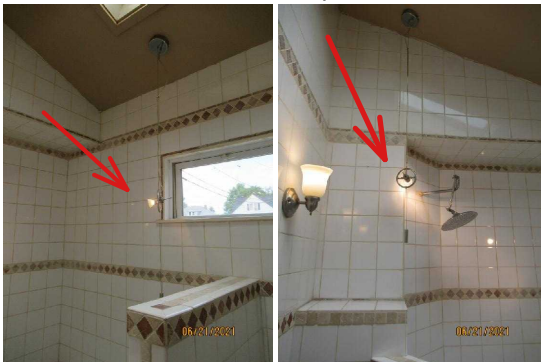
23. ☐☐☐☐☒ Electrical: Light fixture / switch poor location in room, A licensed electrician is recommended to evaluate and estimate repairs

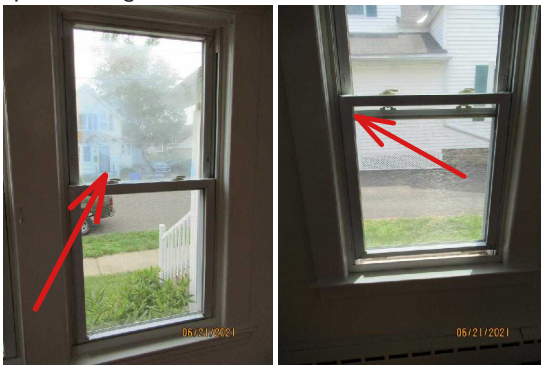
1. ☒ ☐ ☐ ☐ ☐ Closet:
2. ☒ ☐ ☐ ☐ ☐ Ceiling:
3. ☒ ☐ ☐ ☐ ☐ Walls:
4. ☒ ☐ ☐ ☐ ☐ Floor:
5. ☒ ☐ ☐ ☐ ☐ Doors:
6. ☐ ☐ ☐ ☐ ☒ Windows: Window has fogging between the layers of glass, Repair faulty operating hardware, A qualified glazier is recommended to evaluate and estimate repairs

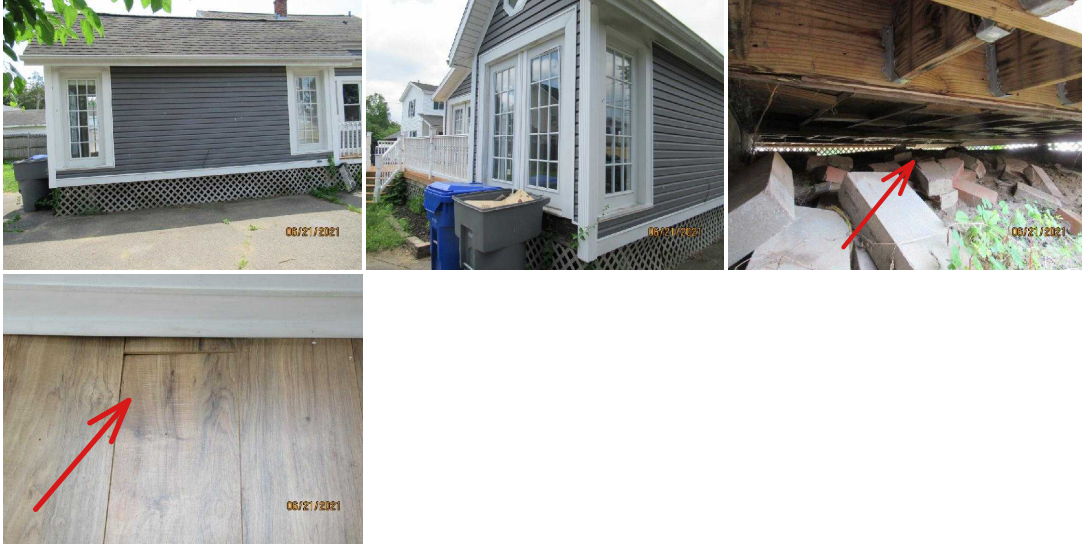
14. ☐☐☐☐☒ Floor: Structurally unsound, Loose flooring, Suggests to have a qualified specialist evaluate this condition

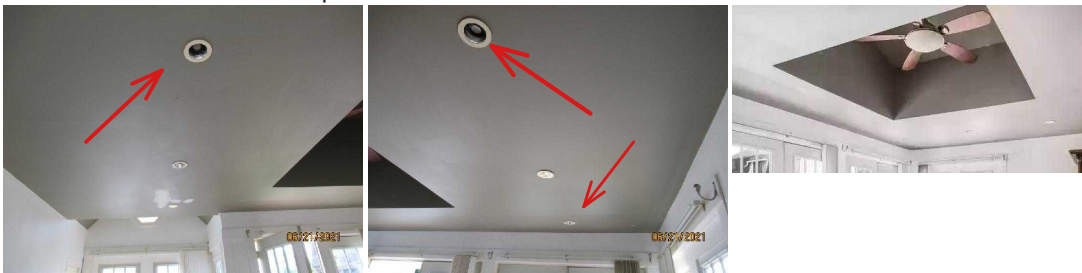
17. ☐☐☐☐☒ Electrical: Damage light fixture, Ceiling fan inoperative, A licensed electrician is recommended to evaluate and estimate repairs

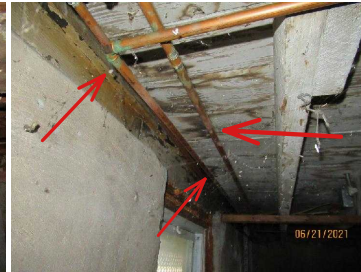
3. ☐ ☐ ☐ ☐ ☒ Water Lines: Not properly supported in hangers, A licensed plumber is recommended to evaluate and estimate repairs

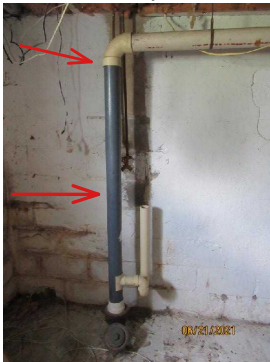
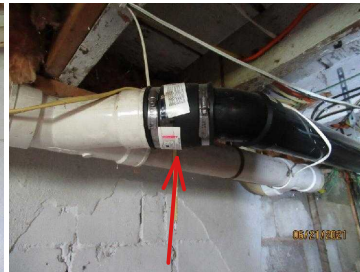
4. ☐ ☐ ☐ ☐ ☒ Drain Pipes: Improper connections at drains, A licensed plumber is recommended to evaluate and estimate repairs

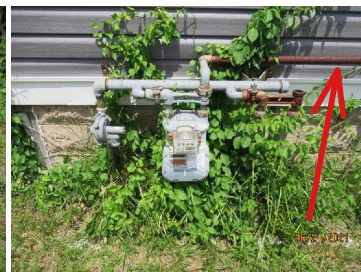
7. ☐ ☐ ☐ ☐ ☒ Gas Service Lines: Line needs capping or removal, Rusting at supply lines , Suggest to have a licensed specialist check and evaluate condition

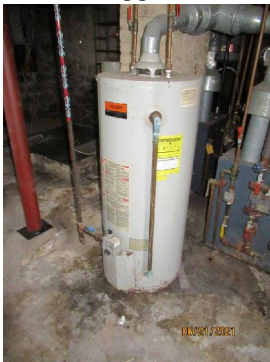
14. ☐☐☐☐☒ Water Heater Operation: Water heater not functioning at time of inspection, Rusting at exterior base , Suggest unit to be serviced by a qualified specialist

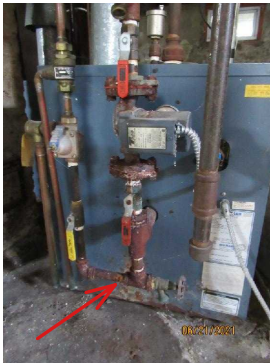
22. ☐ ☐ ☐ ☐ ☒ Distribution: Significant rusting at pipe, A qualified heating system contractor is recommended to evaluate and estimate repairs

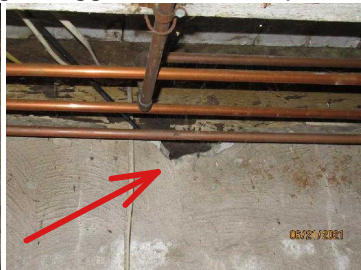
1. ☒ ☐ ☐ ☐ ☐ Structure Type: Wood frame
2. ☐ ☐ ☐ ☐ ☒ Foundation: Gaps an openings, Suggest to have a qualified specialist to evaluate condition

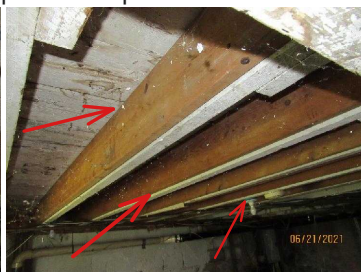
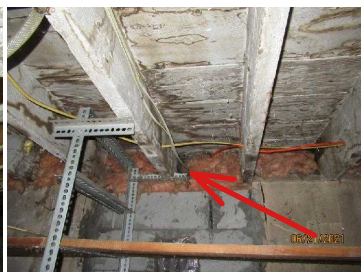
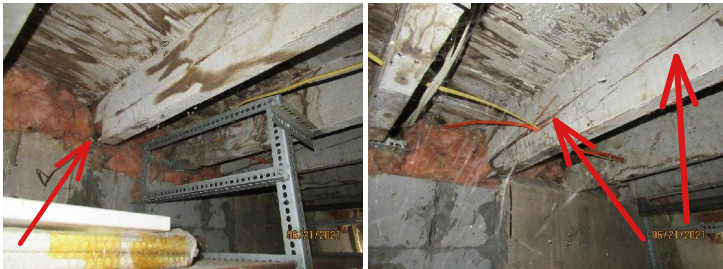
3. ☐ ☒ ☐ ☐ ☐ Differential Movement:
4. ☒ ☐ ☐ ☐ ☐ Beams:
5. ☒ ☐ ☐ ☐ ☐ Bearing Walls:
6. ☐ ☐ ☐ ☐ ☒ Joists/Trusses: Repairs noted in basement area, Floor joist damaged / cut, Floor joist split or cracked, Suggest to have a qualified specialist to check and evaluate condition

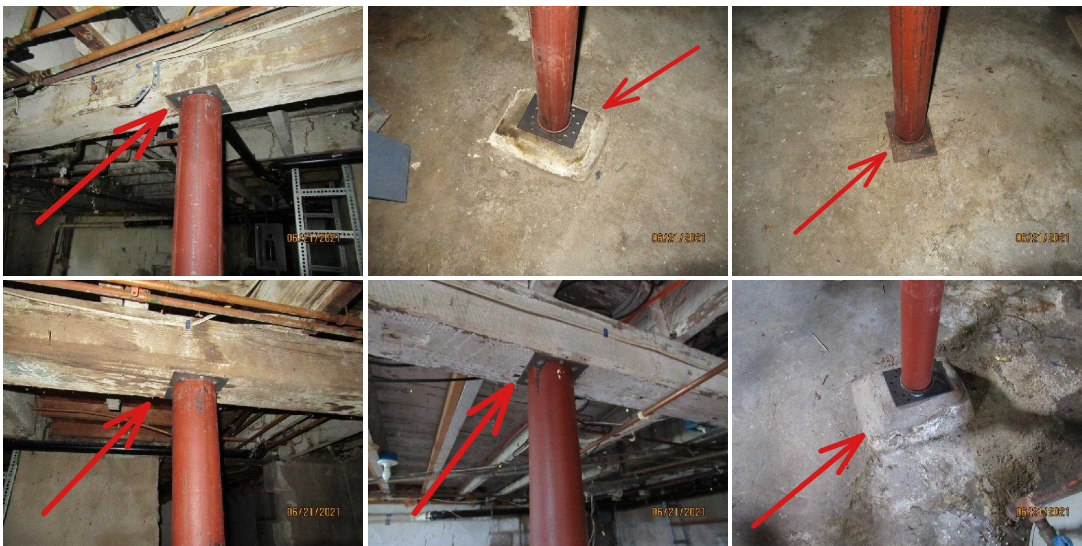
7. ☐☐☐☐☒ Piers/Posts: Posts improperly installed, Suggest to have a qualified specialist evaluate this condition

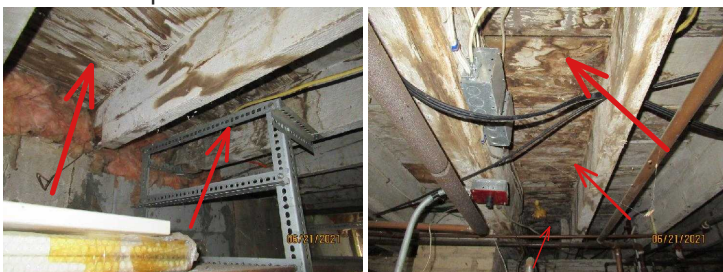
8. ☒☐☐☐☐ Floor/Slab:
9. ☐☐☐☐☒ Subfloor: Mildew or moisture stains visible, A qualified contractor is recommended to evaluate and estimate repairs

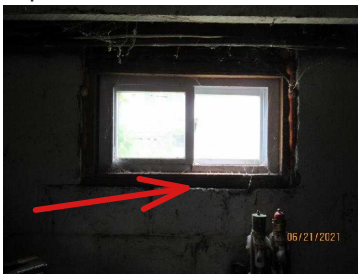
1. ☐ ☒ ☐ ☐ ☐ Ceiling:
2. ☐ ☒ ☐ ☐ ☐ Walls:
3. ☐ ☒ ☐ ☐ ☐ Floor:
4. ☐ ☒ ☐ ☐ ☐ Floor Drain:
5. ☒ ☐ ☐ ☐ ☐ Doors:
6. ☐ ☐ ☐ ☐ ☒ Windows: Gasps in window frame, A qualified glazier is recommended to evaluate and estimate repairs

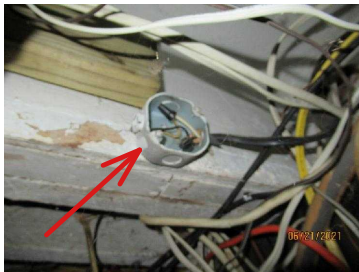
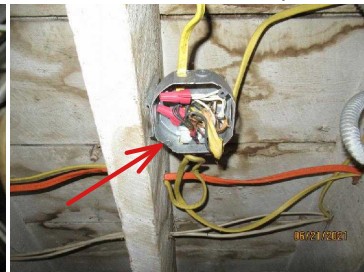
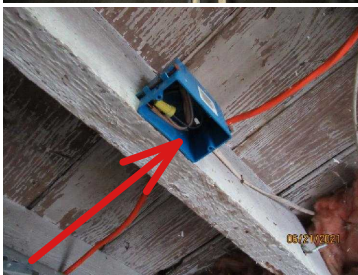
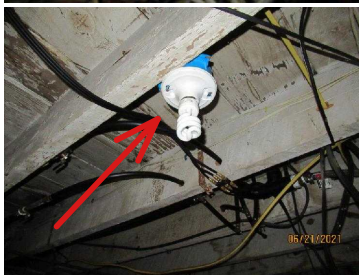
7. ☐ ☐ ☐ ☐ ☒ Electrical: Improper wiring, Open/loose junction box/s, Light fixtures not functioning at time of inspection , A licensed electrician is recommended to evaluate and estimate repairs

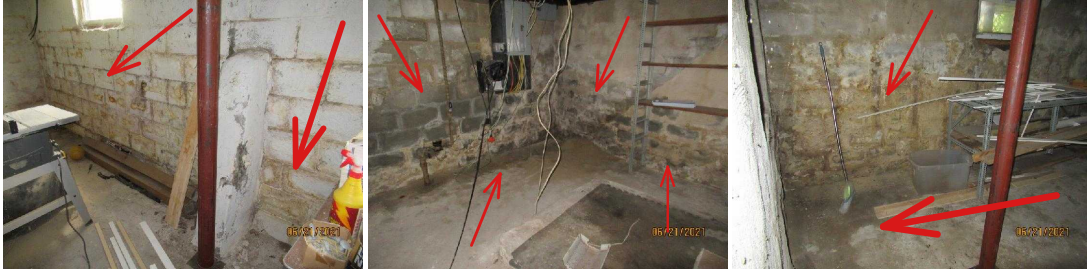
13. ☐☐☐☐☒ Moisture Location: Efflorescence present at foundation walls, Water stains present, A qualified contractor is recommended to evaluate and estimate repairs

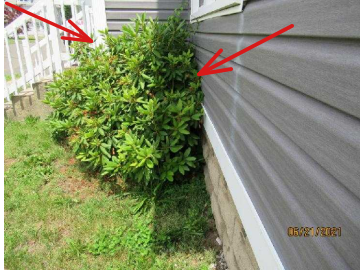
1. Vegetation: Bushes too close to structure should be trimmed back 1 foot

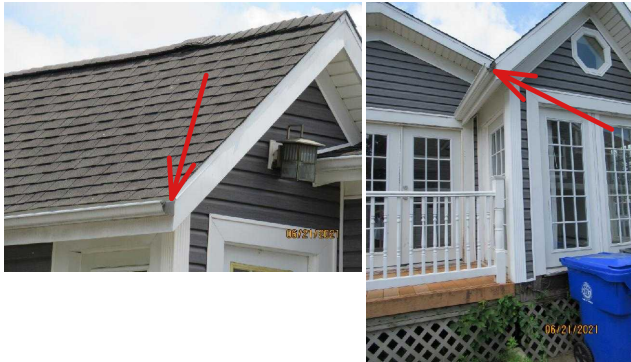
2. Gutters: Incomplete gutter system
3. Downspouts: Missing

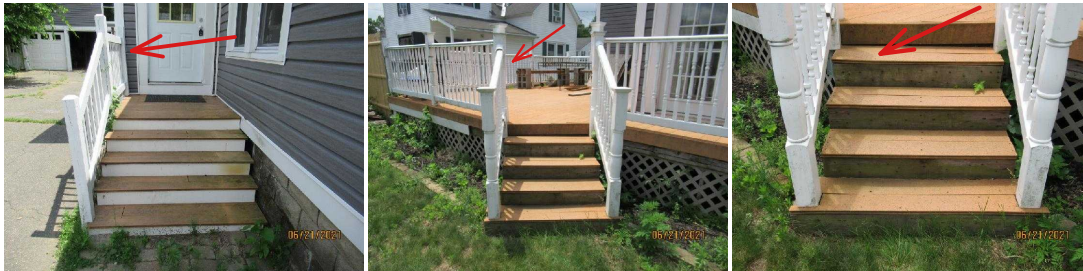
1. Steps/Stoops: Handrails not secure, Steps not secured, A qualified contractor is recommended to evaluate and estimate repairs

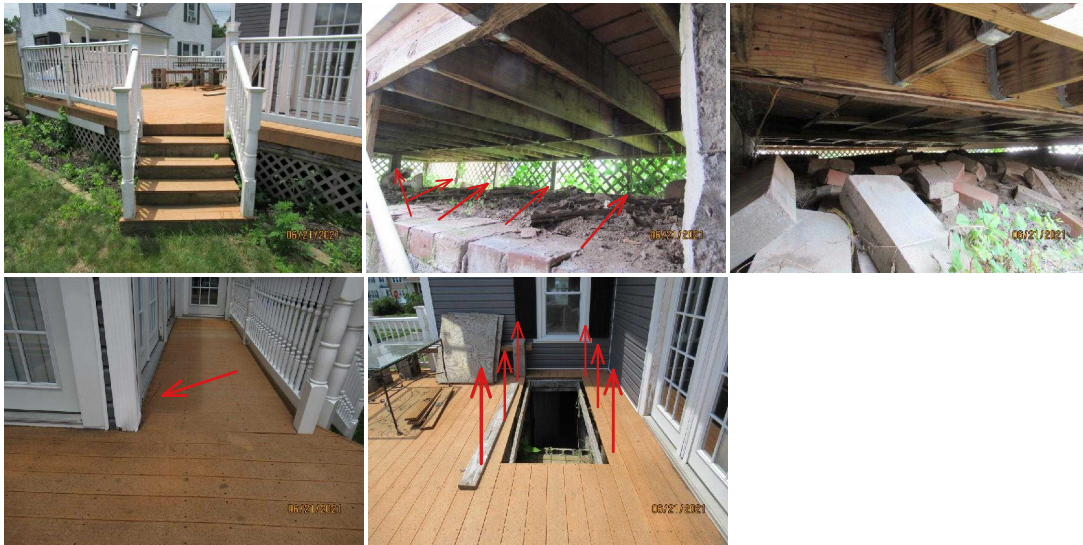
2. Deck: Structurally unsound, Not built to code or standards, Negative slope , Missing guard rails

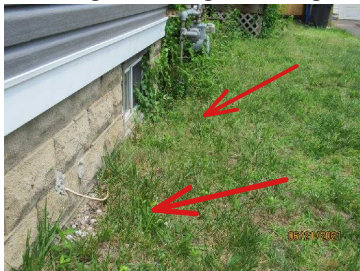
3. Grading: Grading has negative slope and water is pooling against the foundation.

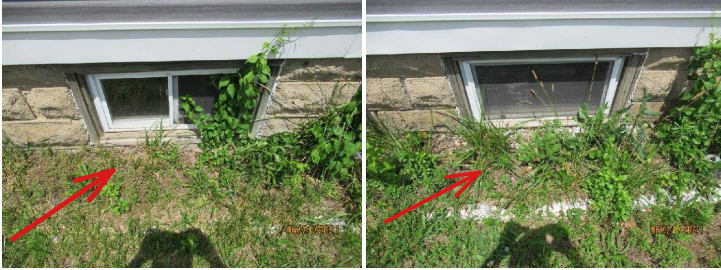
4. Window Wells: Missing, At grade or below grade level, A qualified contractor is recommended to evaluate and estimate repairs

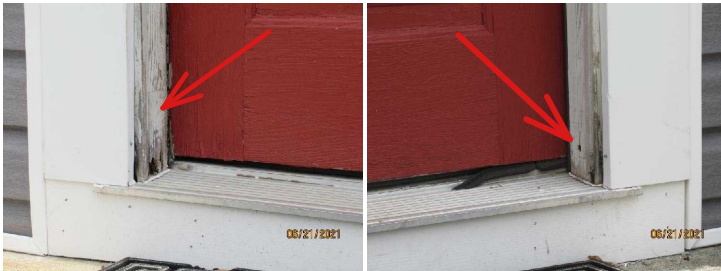
10. Entry Doors: Wood rot, Paint peeling, A qualified contractor is recommended to evaluate and estimate repairs

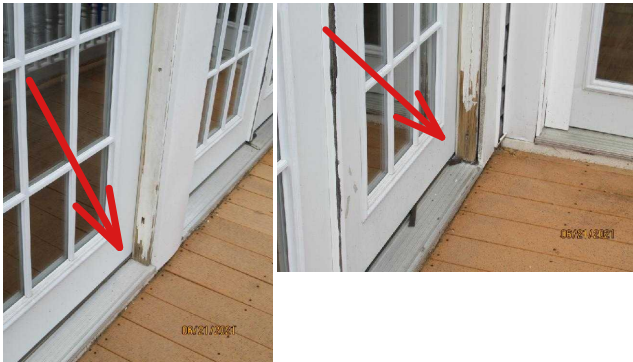
11. Patio Door: Paint peeling, A qualified contractor is recommended to evaluate and estimate repairs

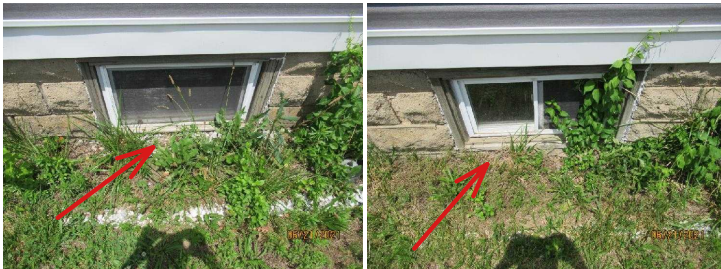
12. Basement Windows: Below grade without window well

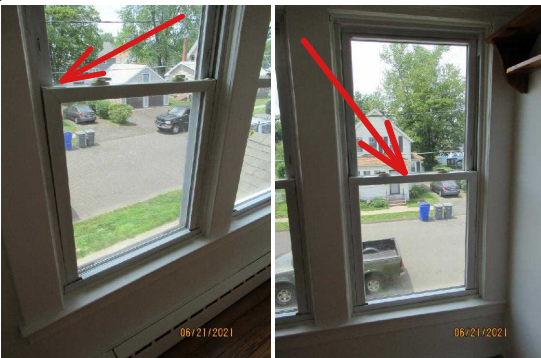
16. 2nd floor right front Bedroom Windows: Repair faulty operating hardware, Missing window screens, A qualified glazier is recommended to evaluate and estimate repairs

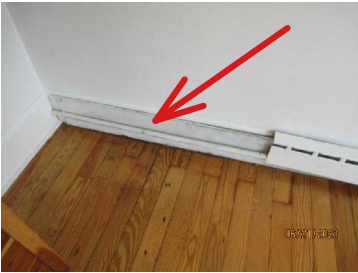
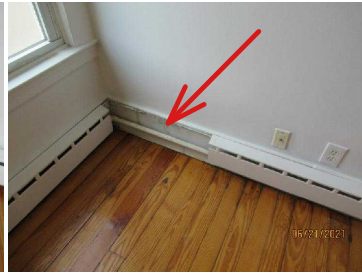
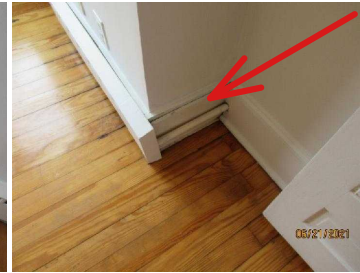
18. 2nd floor right front Bedroom HVAC Source: Heating system inoperable, Register cover missing

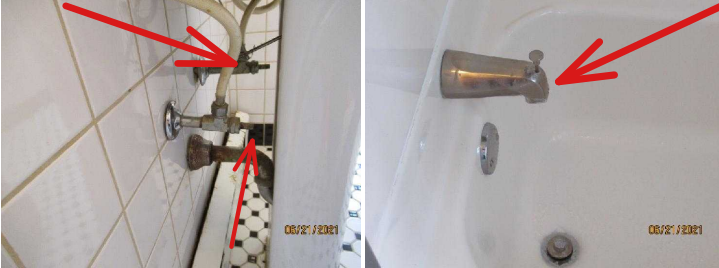
21. 2nd floor Hall bathroom Bathroom Faucets/Traps: Shutoff valve defective, Shower diverter not functioning properly, all water is not flowing to showerhead, A licensed plumber is recommended to evaluate and estimate repairs

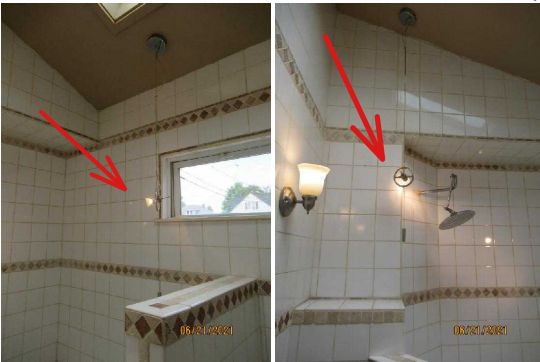
23. Hall Bathroom 1st Fl Bathroom Electrical: Light fixture / switch poor location in room, A licensed electrician is recommended to evaluate and estimate repairs

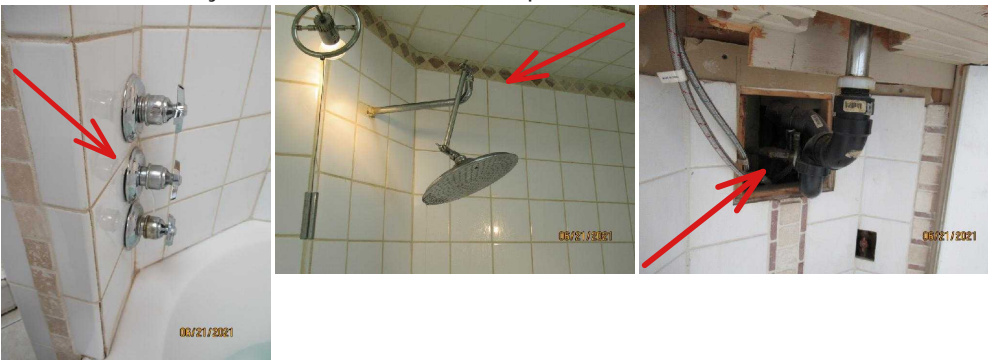
24. Hall Bathroom 1st Fl Bathroom Faucets/Traps: Leaking control handle, Leak at shower head , "S" Type drain traps do not meet today's standards, A licensed plumber is recommended to evaluate and estimate repairs

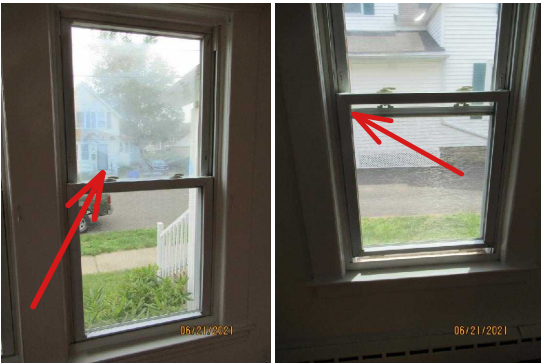
27. 1st floor, Living room Living Space Windows: Window has fogging between the layers of glass, Repair faulty operating hardware, A qualified glazier is recommended to evaluate and estimate repairs

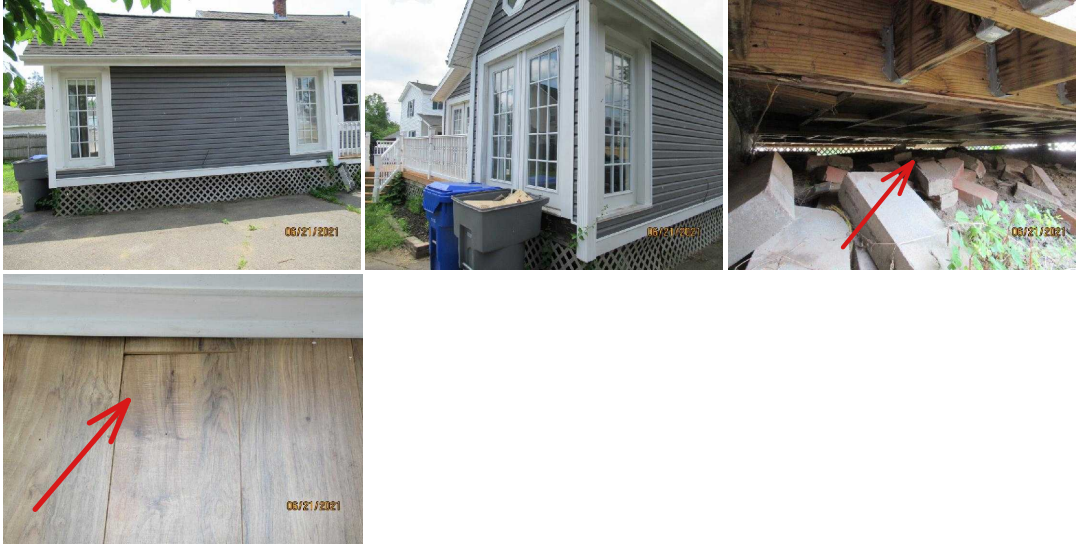
29. 1st floor, Family Room Living Space Floor: Structurally unsound, Loose flooring, Suggests to have a qualified specialist evaluate this condition

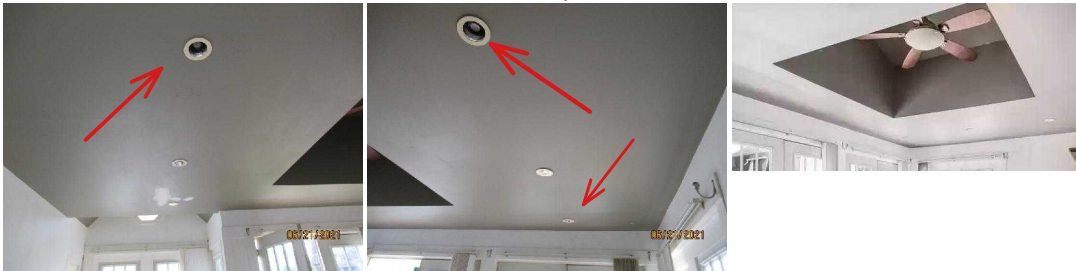
30. 1st floor, Family Room Living Space Electrical: Damage light fixture, Ceiling fan inoperative, A licensed electrician is recommended to evaluate and estimate repairs

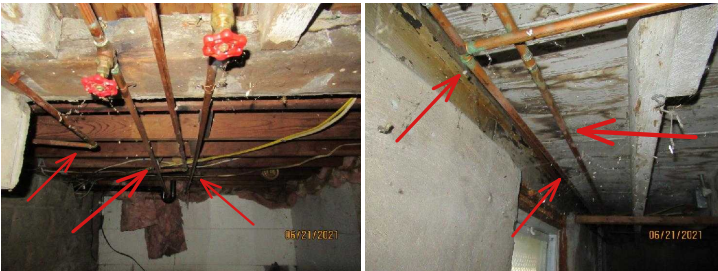
35. Water Lines: Not properly supported in hangers, A licensed plumber is recommended to evaluate and estimate repairs

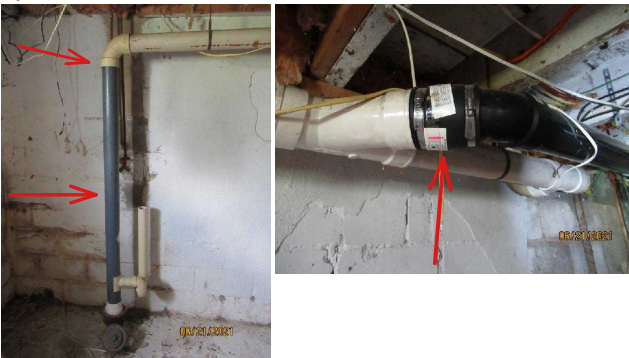
36. Drain Pipes: Improper connections at drains, A licensed plumber is recommended to evaluate and estimate repairs

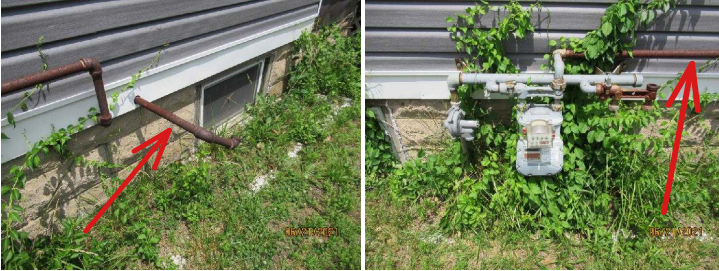
37. Gas Service Lines: Line needs capping or removal, Rusting at supply lines , Suggest to have a licensed specialist check and evaluate condition

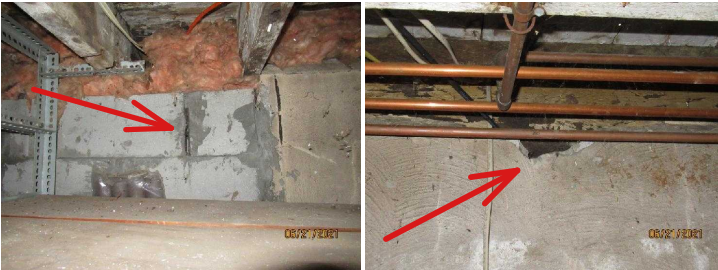
46. Foundation: Gaps and openings, Suggest to have a qualified specialist to evaluate condition

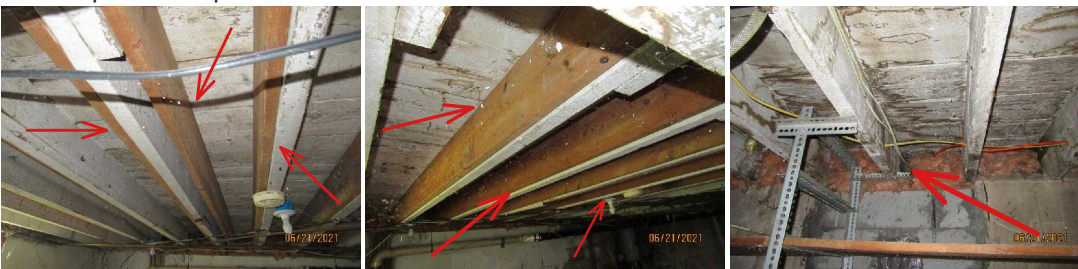
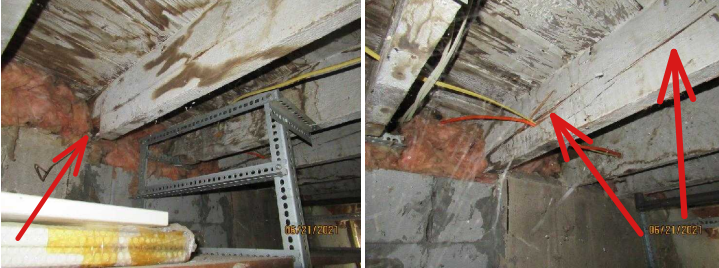
47. Joists/Trusses: Repairs noted in basement area, Floor joist damaged / cut, Floor joist split or cracked, Suggest to have a qualified specialist to check and evaluate condition

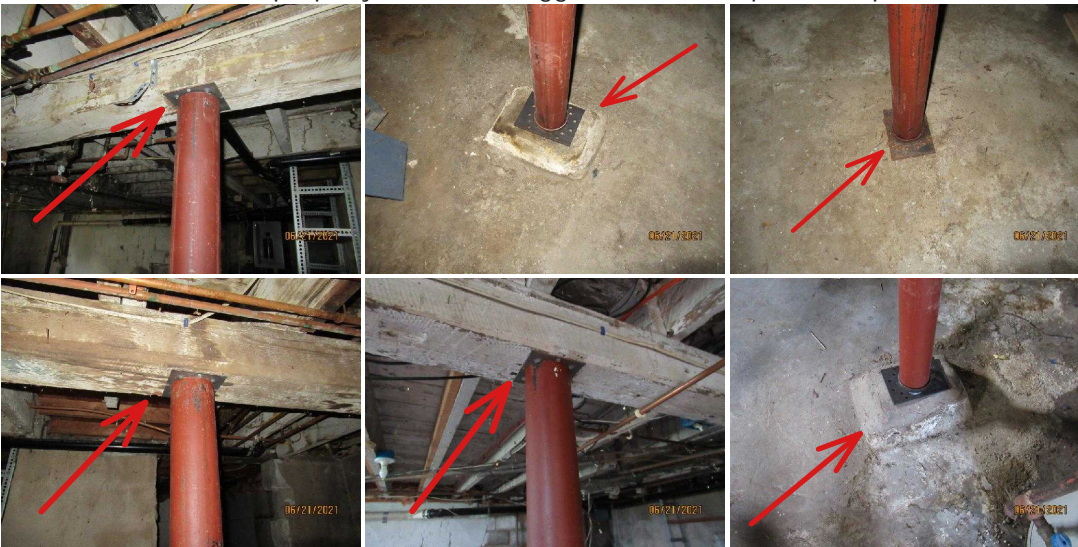
48. Piers/Posts: Posts improperly installed, Suggest to have a qualified specialist evaluate this condition

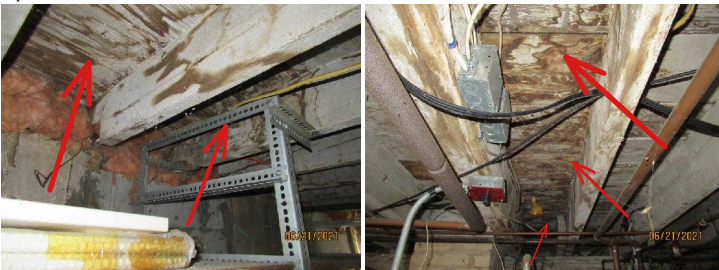
49. Subfloor: Mildew or moisture stains visible, A qualified contractor is recommended to evaluate and estimate repairs

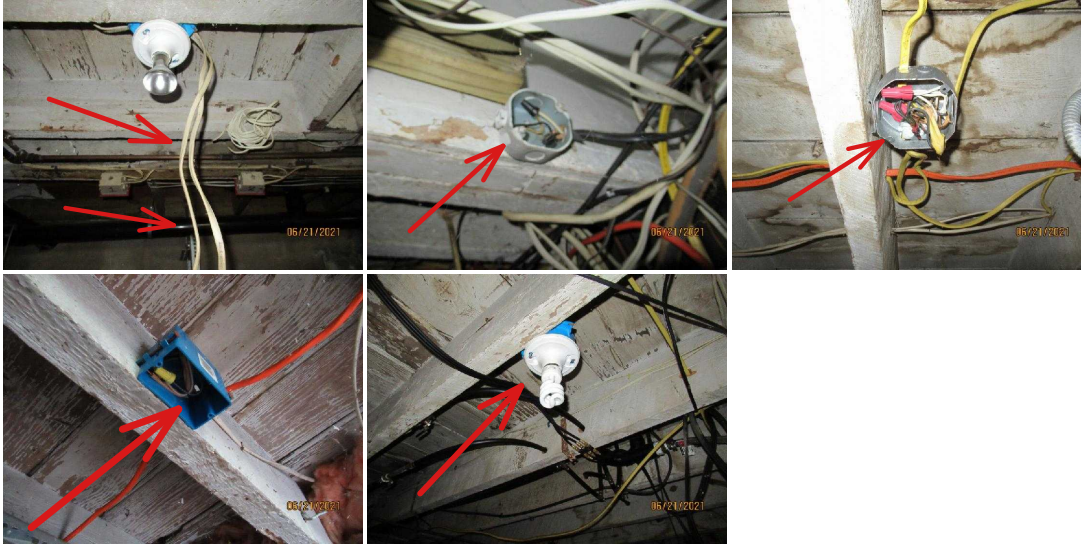
51. Main Basement Electrical: Improper wiring, Open/loose junction box/s, Light fixtures not functioning at time of inspection , A licensed electrician is recommended to evaluate and estimate repairs

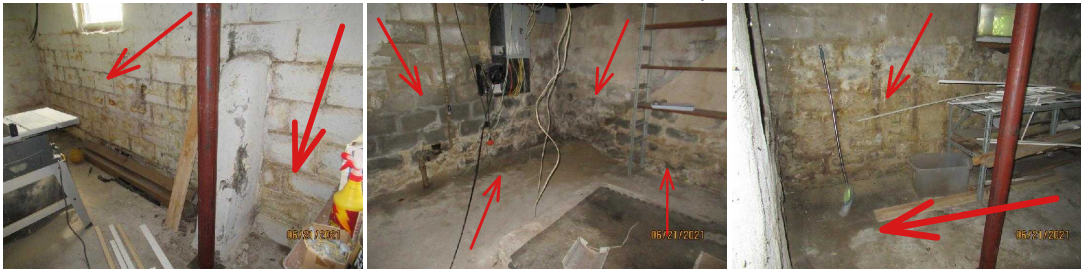
52. Main Basement Moisture Location: Efflorescence present at foundation walls, Water stains present, A qualified contractor is recommended to evaluate and estimate repairs
