Home Inspection Report

0 St
Springfield, Connecticut 06082

Inspected by:
Ernest Harris
Harris Property Inspections

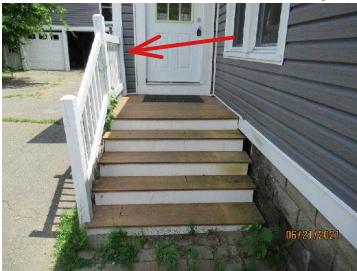
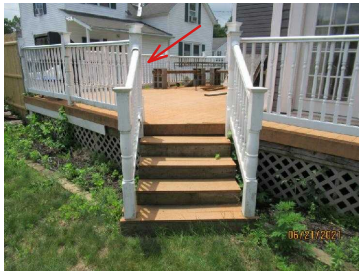
3. ☐ ☐ ☐ ☐ ☒ Steps/Stoops: Handrails not secure, Steps not secured, A qualified contractor is recommended to evaluate and estimate repairs

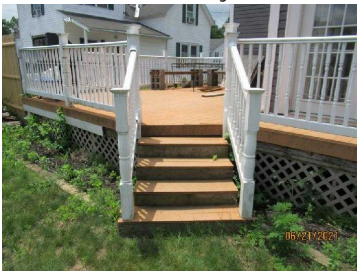
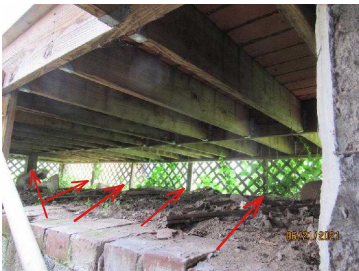
6. ☐ ☐ ☐ ☐ ☒ Deck: Structurally unsound, Not built to code or standards, Negative slope , Missing guard rails

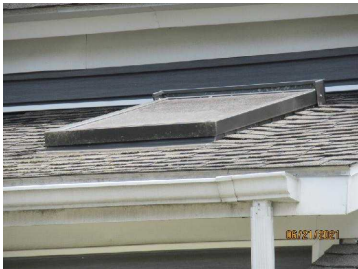
2. ☐☐☐☐☒ Material: Asphalt shingle - Moss growth on roof shingle surface, A qualified roofing contractor is recommended to evaluate and estimate repairs
3. Type: Gable
4. Approximate Age: 10-15 years
5. ☒☐☐☐☐ Flashing:
6. ☒☐☐☐☐ Valleys:
7. ☒☐☐☐☐ Skylights:

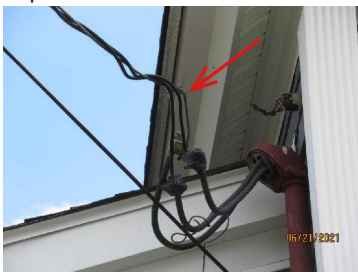
8. ☒☐☐☐☐ Plumbing Vents:
9. ☐☐☐☐☒ Electrical Mast: Broken ground, A qualified contractor is recommended to evaluate and estimate repairs

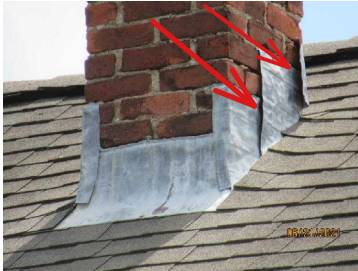
14. ☐☐☐☒☐ Flue/Flue Cap: Recommend adding rain/snow cap
15. ☐☐☐☒☐ Chimney Flashing: Loose counter flashing- repair

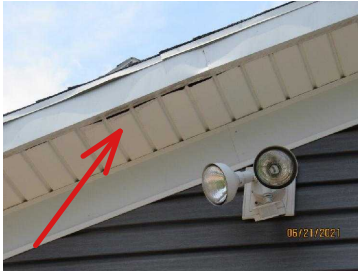
1. ☒ ☐ ☐ ☐ ☐ Type: Vinyl siding
2. ☒ ☐ ☐ ☐ ☐ Trim:
3. ☒ ☐ ☐ ☐ ☐ Fascia:
4. ☐ ☐ ☐ ☐ ☒ Soffits: Loose

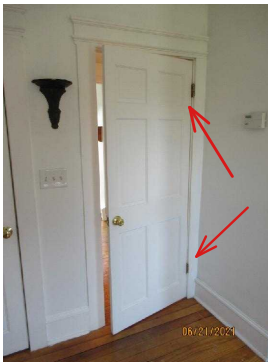
1. ☒ ☐ ☐ ☐ ☐ Closet:
2. ☒ ☐ ☐ ☐ ☐ Ceiling:
3. ☒ ☐ ☐ ☐ ☐ Walls:
4. ☒ ☐ ☐ ☐ ☐ Floor:
5. ☐ ☐ ☐ ☐ ☒ Doors: Doors need trimming/adjustment

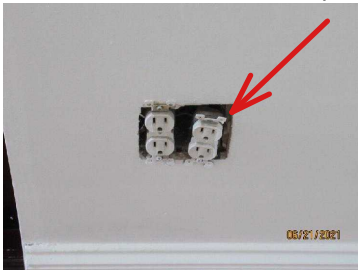
6. ☒ ☐ ☐ ☐ ☐ Windows:
7. ☐ ☐ ☐ ☐ ☒ Electrical: Loose switch or outlet should be resecured, A licensed electrician is recommended to evaluate and estimate repairs

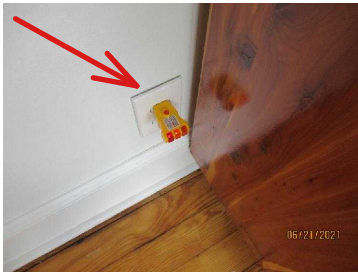
15. ☐☐☐☐☒ Electrical: Open grounds noted at 3 prong outlets, Loose switch or outlet should be resecured, A licensed electrician is recommended to evaluate and estimate repairs

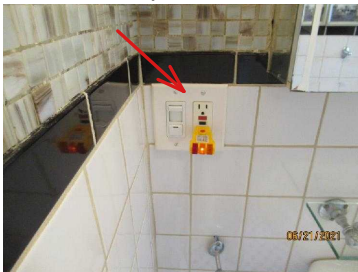
7. ☐ ☐ ☐ ☐ ☒ Electrical: Faulty GFCI outlet-replace, A licensed electrician is recommended to evaluate and estimate repairs

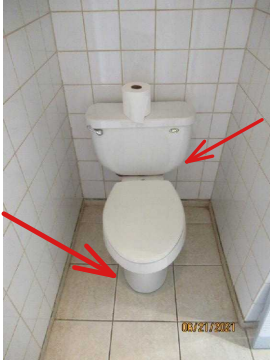
14. ☐☐☐☐☒ Toilets: Loose tank on toilet, The toilet is loose at the floor and will require replacement of the wax seal, Suggest having a licensed plumber check and evaluate condition

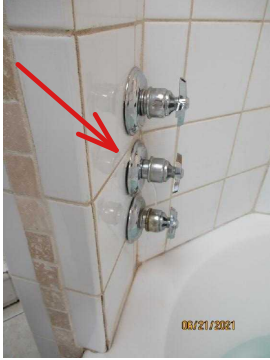
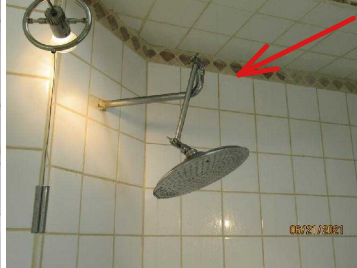
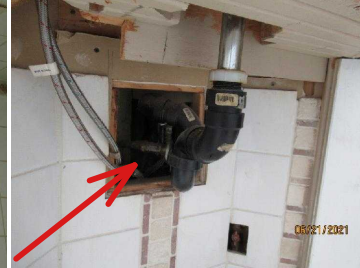
26. ☐☐☐☐☒ Faucets/Traps: Leaking control handle, Leak at shower head , "S" Type drain traps do not meet today's standards, A licensed plumber is recommended to evaluate and estimate repairs

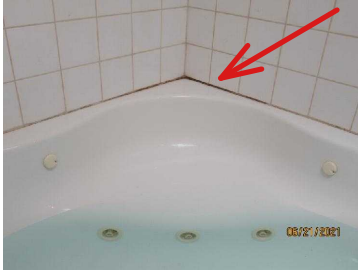
27. ☐ ☒ ☐ ☐ ☐ Tub/Surround:
28. ☐ ☐ ☐ ☐ ☒ Shower/Surround: Opening at shower wall needs sealing

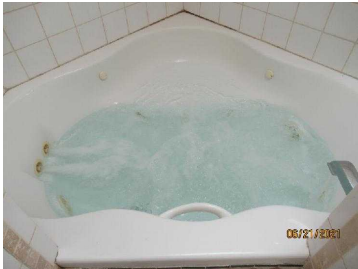
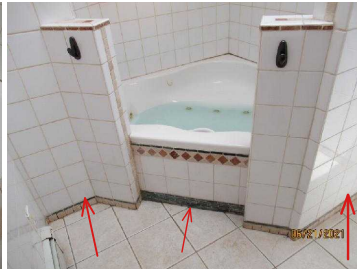
29. ☐ ☐ ☐ ☒ ☐ Spa Tub/Surround: No access panel to components

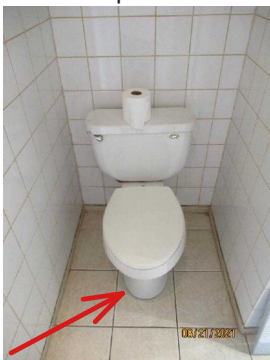
30. ☐ ☐ ☐ ☐ ☒ Toilets: The toilet is loose at the floor and will require replacement of the wax seal, Suggest having a licensed plumber check and evaluate condition

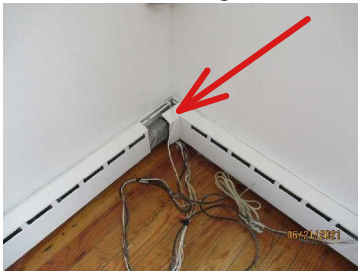
7. ☒ ☐ ☐ ☐ ☐ Electrical:
8. ☐ ☐ ☐ ☐ ☒ HVAC Source: Register cover missing, Heating system inoperable

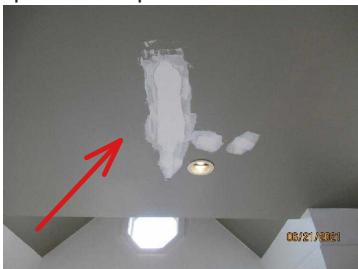
11. ☐ ☒ ☐ ☐ ☐ Closet:
12. ☐ ☐ ☐ ☒ ☐ Ceiling: Patching in ceiling, condition may reveal hidden defects, suggest to have evaluated by qualified specialist

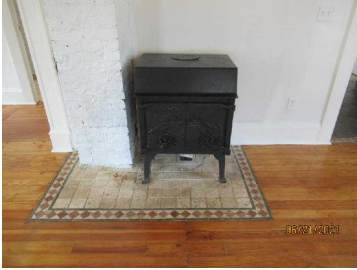
1. ☐☐☐☒☐ Freestanding Stove: Wood burning - Not installed at time of inspection

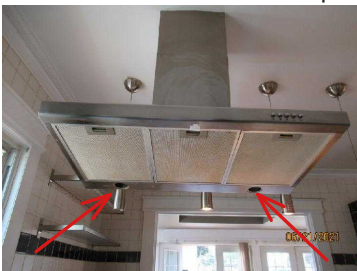
1. ☒☐☐☐☐ Cooking Appliances: Cook top
2. ☐☐☐☐☒ Ventilator: Light not functioning at time of inspection, A licensed electrician is recommended to evaluate and estimate repairs

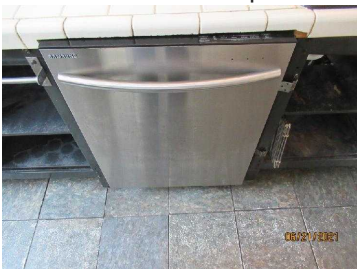
3. ☐☒☐☐☐ Disposal:
4. ☐☐☐☐☒ Dishwasher: Dishwasher failed to drain during sump cycle, Not Properly secured to counter / base cabinet, A licensed plumber is recommended to evaluate and estimate repairs

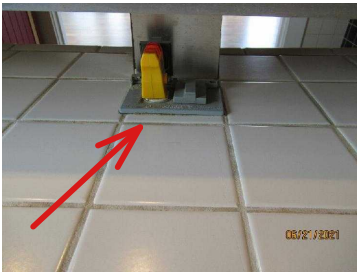
10. ☐ ☐ ☐ ☐ ☒ Electrical: Non-GFCI circuit -recommend GFCI circuit be installed, A licensed electrician is recommended to evaluate and estimate repairs

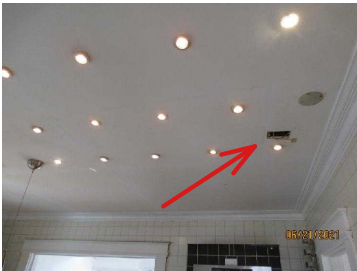
15. ☐ ☐ ☐ ☒ ☐ Ceiling: Gaps or openings

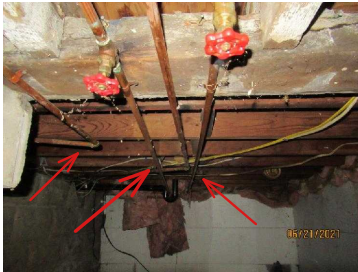
3. ☐ ☐ ☐ ☐ ☒ Water Lines: Not properly supported in hangers, A licensed plumber is recommended to evaluate and estimate repairs

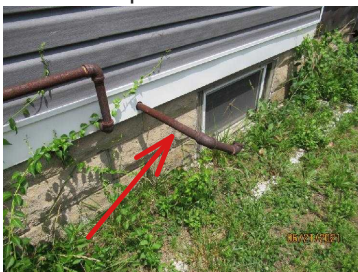
7. ☐ ☐ ☐ ☐ ☒ Gas Service Lines: Line needs capping or removal, Rusting at supply lines , Suggest to have a licensed specialist check and evaluate condition

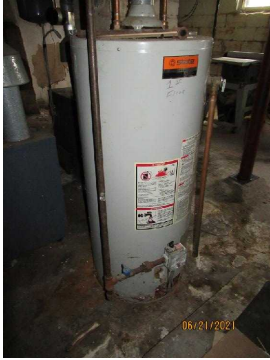
Basement, 1st floor unit Water Heater

8. ☐☐☐☐☒ Water Heater Operation: Water heater not functioning at time of inspection, Significantly rusting , No vacuum breaker on cold water supply to tank , Suggest unit to be serviced by a qualified specialist, Significantly rusting , No vacuum breaker on cold water supply to tank , Suggest unit to be serviced by a qualified specialist

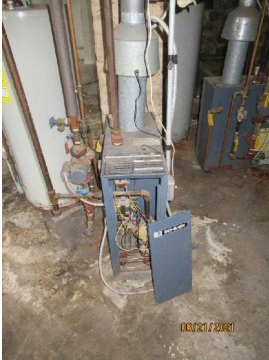
Basement Heating System

1. ☐☐☐☐☒ Heating System Operation: Failed to respond to normal user controls - Not functioning at time of inspection, Rusting at exterior, Service recommended, A qualified specialist to check and evaluate system

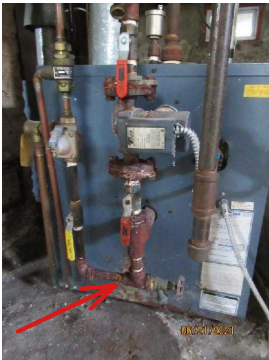
2. Manufacturer: Weil McLain
3. Type: Boiler / Forced Hot Water Capacity:
4. Area Served: Unknown Approximate Age: 1991
5. Fuel Type: Natural gas
6. ☐☐☒☐ Heat Exchanger:
7. ☐☒☐☐ Blower Fan/Filter:
8. ☐☐☐☒ Distribution: Significant rusting at pipe, A qualified heating system contractor is recommended to evaluate and estimate repairs

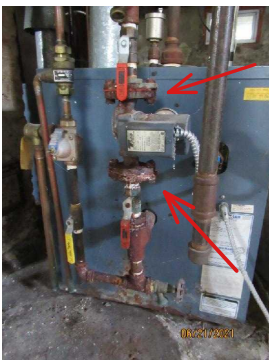
9. ☐☐☐☒ Circulator: Circulating pump shows signs of past or present leakage, A qualified heating system contractor is recommended to evaluate and estimate repairs

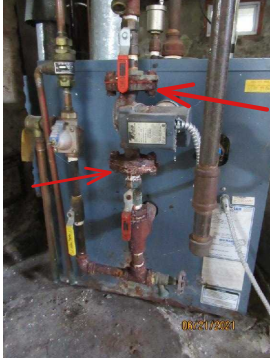
Circulator: (continued)

23. ☐ ☐ ☐ ☐ ☒ Circulator: Circulating pump shows signs of past or present leakage, A qualified heating system contractor is recommended to evaluate and estimate repairs

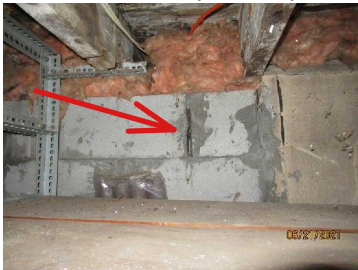
1. ☒ ☐ ☐ ☐ ☐ Structure Type: Wood frame
2. ☐ ☐ ☐ ☐ ☒ Foundation: Gaps an openings, Suggest to have a qualified specialist to evaluate condition

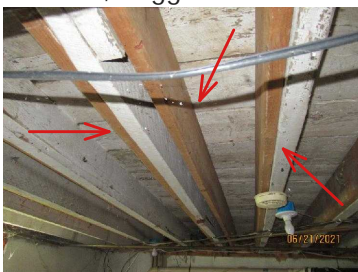
3. ☐ ☒ ☐ ☐ ☐ Differential Movement:
4. ☒ ☐ ☐ ☐ ☐ Beams:
5. ☒ ☐ ☐ ☐ ☐ Bearing Walls:
6. ☐ ☐ ☐ ☐ ☒ Joists/Trusses: Repairs noted in basement area, Floor joist damaged / cut, Floor joist split or cracked, Suggest to have a qualified specialist to check and evaluate condition

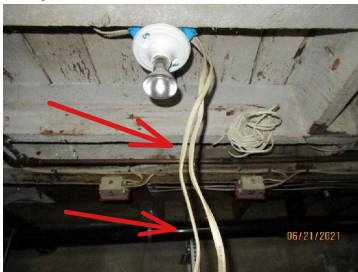
7. ☐ ☐ ☐ ☐ ☒ Electrical: Improper wiring, Open/loose junction box/s, Light fixtures not functioning at time of inspection , A licensed electrician is recommended to evaluate and estimate repairs

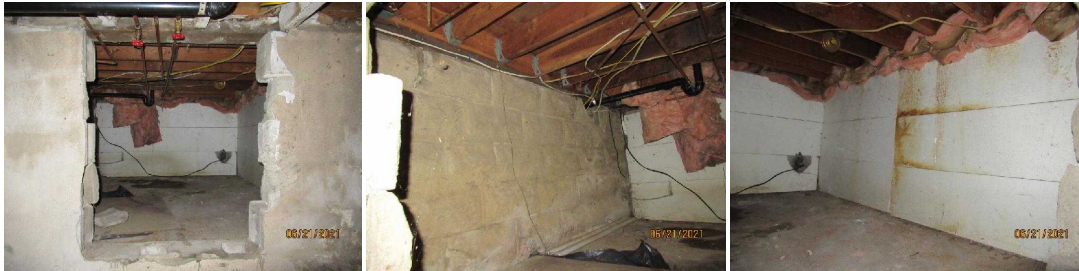
Front of home Crawl Space

2. ☒☐☐☐☐ Access:
3. ☐☐☐☒☐ Moisture Penetration: Not visible
4. Moisture Location:
5. ☐☒☐☐☐ Moisture Barrier:
6. ☒☐☐☐☐ Ventilation:
7. ☒☐☐☐☐ Insulation:
8. ☐☒☐☐☐ Vapor Barrier:
9. ☐☒☐☐☐ Sump Pump:
10. ☒☐☐☐☐ Electrical:
11. ☐☒☐☐☐ HVAC Source:

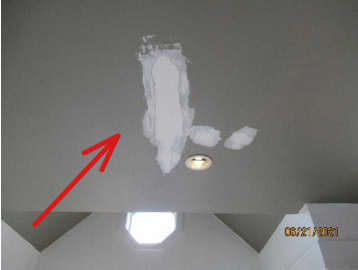
13. 1st floor, Family Room Living Space Ceiling: Patching in ceiling, condition may reveal hidden defects, suggest to have evaluated by qualified specialist

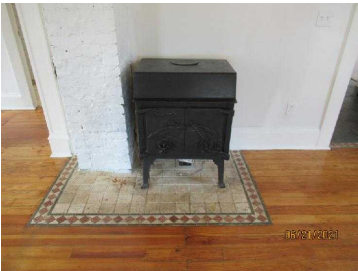
15. Living Room Fireplace Freestanding Stove: Wood burning - Not installed at time of inspection

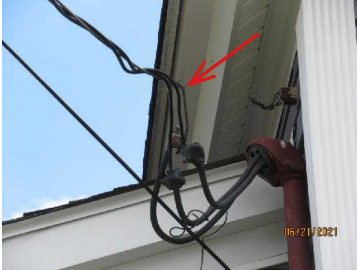
5. Main Roof Surface Material: Asphalt shingle - Moss growth on roof shingle surface, A qualified roofing contractor is recommended to evaluate and estimate repairs
6. Electrical Mast: Broken ground, A qualified contractor is recommended to evaluate and estimate repairs

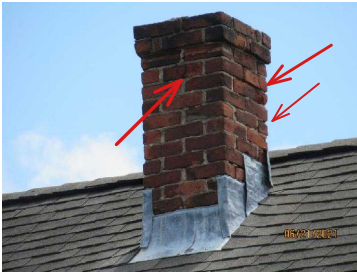
7. Chimney Chimney: Bricks have broken or popped surfaces- repairs required, Chimney requires tuck point repairs, A qualified contractor is recommended to evaluate and estimate repairs

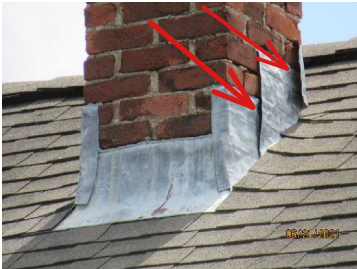
8. Chimney Chimney Flashing: Loose counter flashing- repair

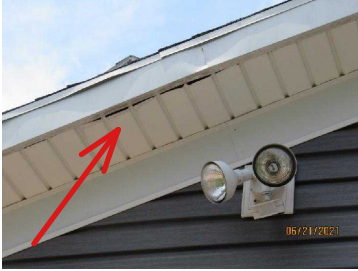
9. Soffits: Loose

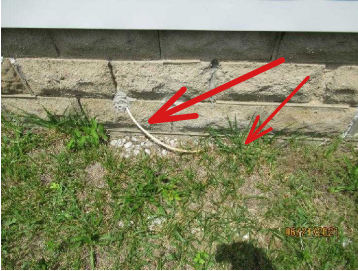
13. Exterior Electric Outlets: Exposed wiring present, Suggest to have a license specialist check and evaluate this condition

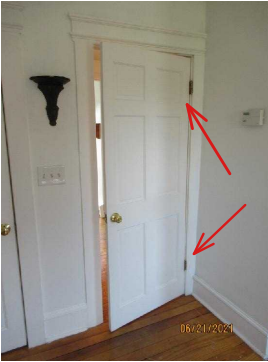
14. 2nd floor right rear Bedroom Doors: Doors need trimming/adjustment

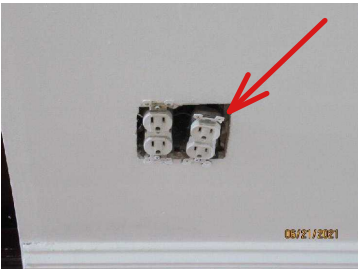
15. 2nd floor right rear Bedroom Electrical: Loose switch or outlet should be resecured, A licensed electrician is recommended to evaluate and estimate repairs

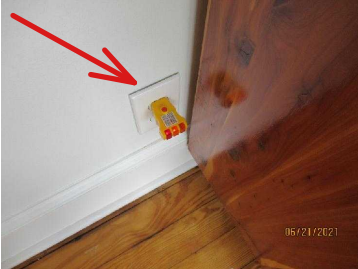
17. 2nd floor right front Bedroom Electrical: Open grounds noted at 3 prong outlets, Loose switch or outlet should be resecured, A licensed electrician is recommended to evaluate and estimate repairs

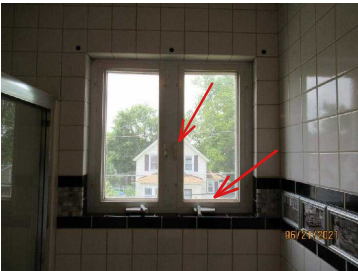
19. 2nd floor Hall bathroom Bathroom Windows: Repair faulty operating hardware, A qualified glazier is recommended to evaluate and estimate repairs

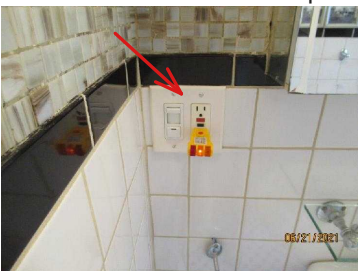
20. 2nd floor Hall bathroom Bathroom Electrical: Faulty GFCI outlet-replace, A licensed electrician is recommended to evaluate and estimate repairs

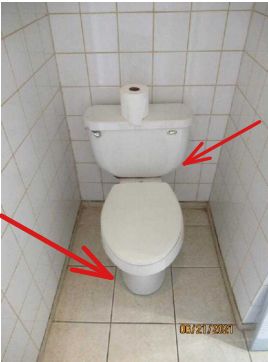
22. 2nd floor Hall bathroom Bathroom Toilets: Loose tank on toilet, The toilet is loose at the floor and will require replacement of the wax seal, Suggest having a licensed plumber check and evaluate condition

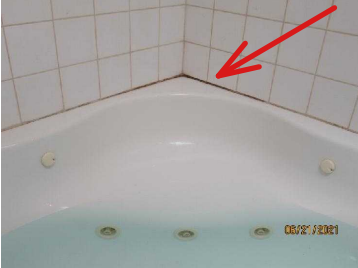
25. Hall Bathroom 1st Fl Bathroom Shower/Surround: Opening at shower wall needs sealing

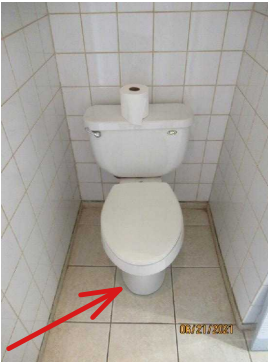
26. Hall Bathroom 1st Fl Bathroom Toilets: The toilet is loose at the floor and will require replacement of the wax seal, Suggest having a licensed plumber check and evaluate condition

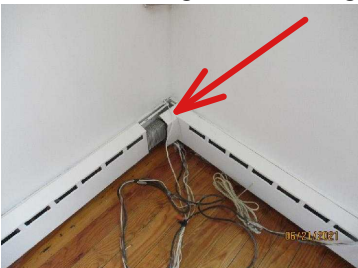
28. 1st floor, Living room Living Space HVAC Source: Register cover missing, Heating system inoperable

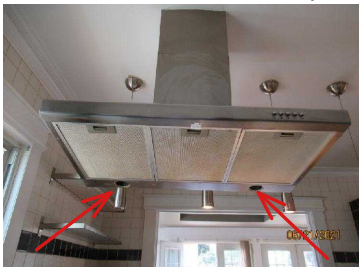
31. 1st Floor Kitchen Ventilator: Light not functioning at time of inspection, A licensed electrician is recommended to evaluate and estimate repairs

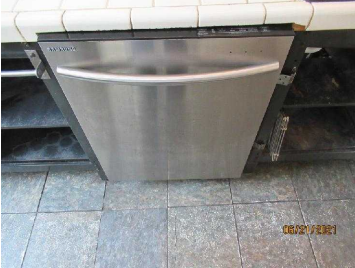
32. 1st Floor Kitchen Dishwasher: Dishwasher failed to drain during sump cycle, Not Properly secured to counter / base cabinet, A licensed plumber is recommended to evaluate and estimate repairs

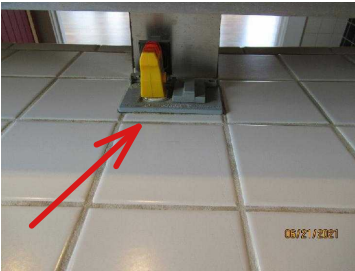
33. 1st Floor Kitchen Electrical: Non-GFCI circuit -recommend GFCI circuit be installed, A licensed electrician is recommended to evaluate and estimate repairs

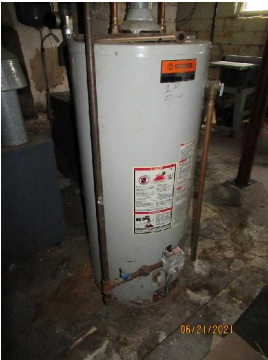
38. Basement, 1st floor unit Water Heater Water Heater Operation: Water heater not functioning at time of inspection, Significantly rusting , No vacuum breaker on cold water supply to tank , Suggest unit to be serviced by a qualified specialist, Significantly rusting , No vacuum breaker on cold water supply to tank , Suggest unit to be serviced by a qualified specialist

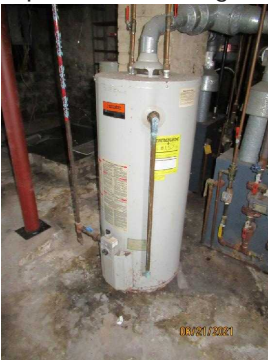
39. Basement, 2nd floor unit Water Heater Water Heater Operation: Water heater not functioning at time of inspection, Rusting at exterior base , Suggest unit to be serviced by a qualified specialist

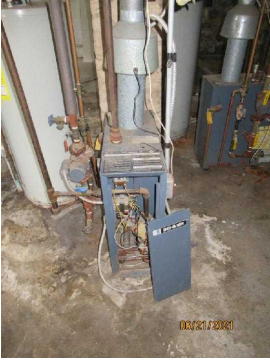
40. Basement Heating System Heating System Operation: Failed to respond to normal user controls - Not functioning at time of inspection, Rusting at exterior, Service recommended, A qualified specialist to check and evaluate system

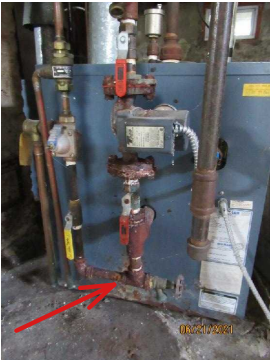
41. Basement Heating System Distribution: Significant rusting at pipe, A qualified heating system contractor is recommended to evaluate and estimate repairs

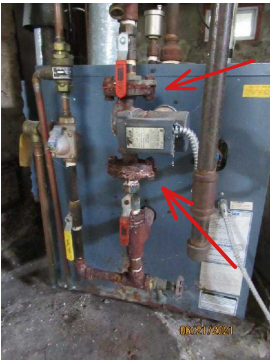
42. Basement Heating System Circulator: Circulating pump shows signs of past or present leakage, A qualified heating system contractor is recommended to evaluate and estimate repairs

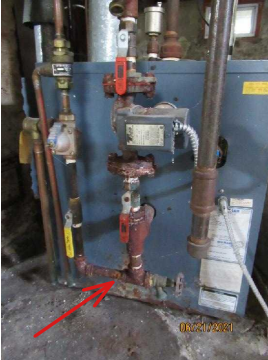
44. Basement Heating System Distribution: Significant rusting at pipe, A qualified heating system contractor is recommended to evaluate and estimate repairs

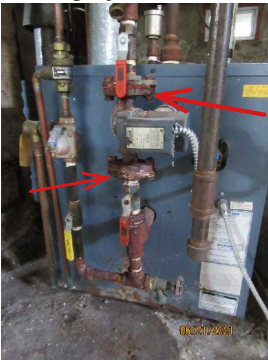
45. Basement Heating System Circulator: Circulating pump shows signs of past or present leakage, A qualified heating system contractor is recommended to evaluate and estimate repairs

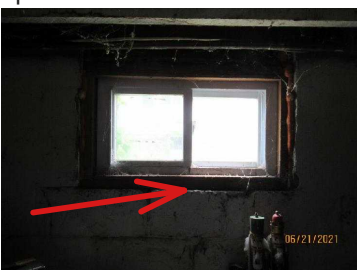
50. Main Basement Windows: Gasps in window frame, A qualified glazier is recommended to evaluate and estimate repairs
